# NON-DESTRUCTIVE METHOD FOR INNER SCALE MEASURING OF BOILER TUBES

<sup>1</sup> CBC Heavy Industries S/A, Brazil

## ABSTRACT

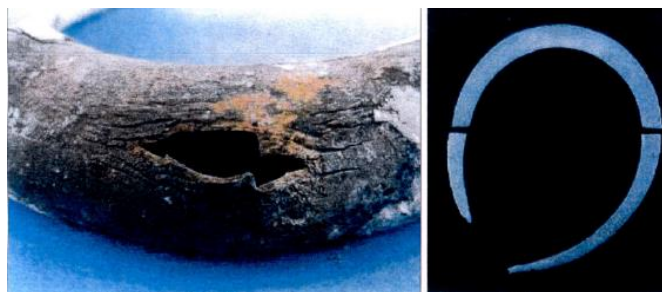
Figure 1 illustrates the occurrence of leakage in the primary superheater of MHI boiler with two (2) drums type after 6 years of operation caused by creep due to the accumulation of oxides on the tube inner surface. At the collapse time the oxide scale was 0.3 mm thick.

**Figure 1: Leakage due to creep caused by oxide accumulation on the tube inner surface**

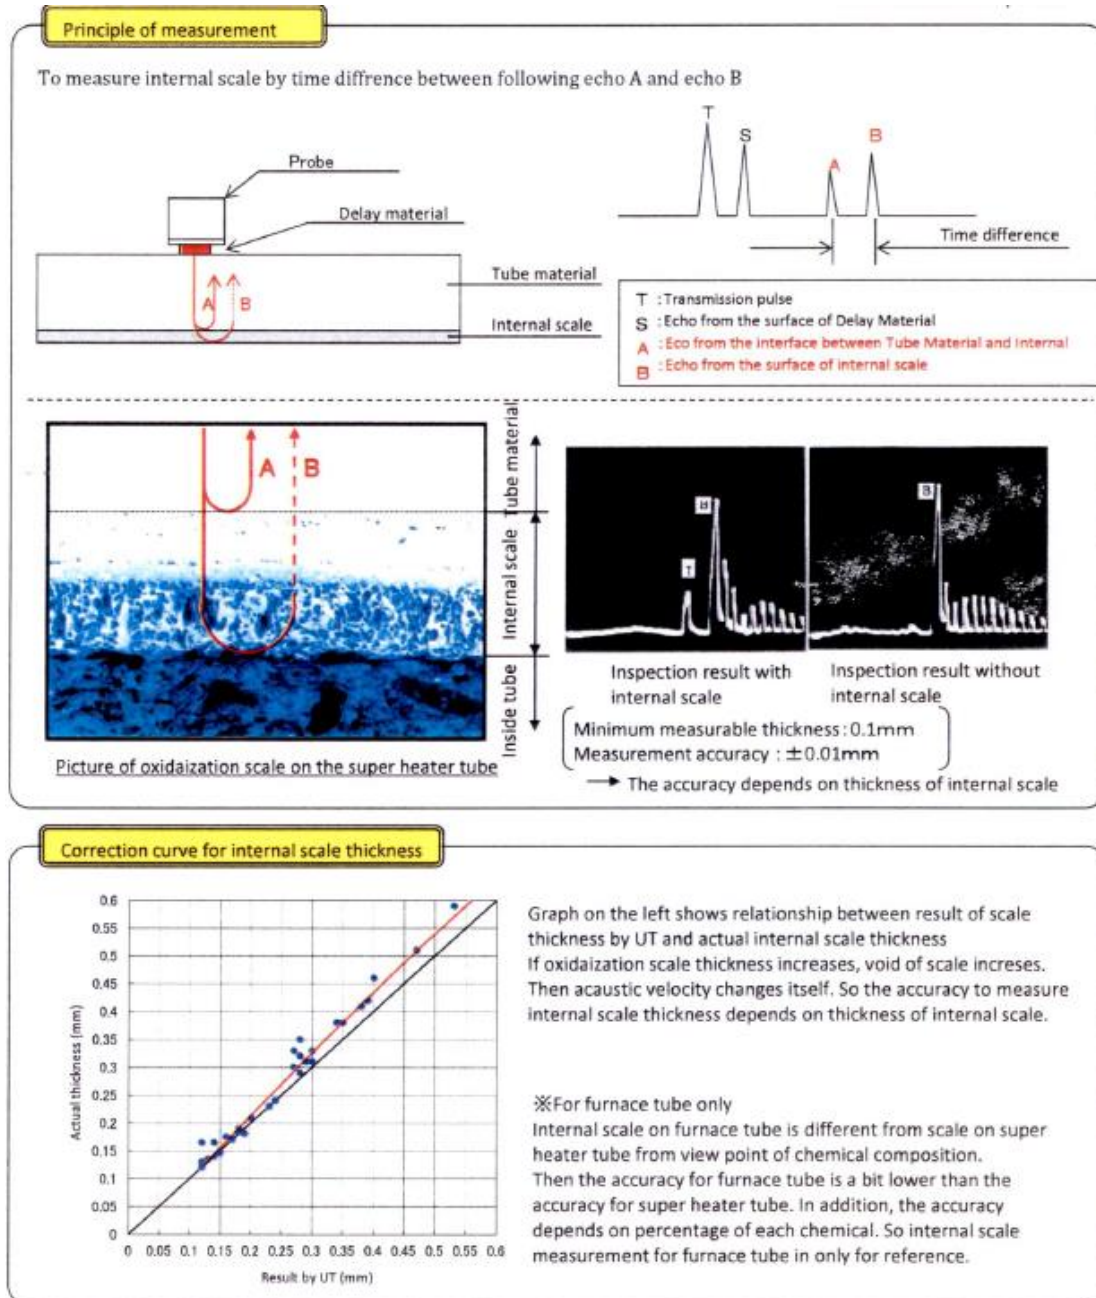
The oxide scale thickness is calculated by measuring the time interval of ultrasonic wave between the reflected echo at the interface steel / oxide scale and reflected echo at the tube inner surface. The echo interface of the steel / oxide scale is much smaller than the echo interface of the oxide

scale / air or liquid on the tube inner surface. The highest difficulty of measurement is to separate these echoes and measure the time interval between them [5].

**Figure 3: Principle of thickness measurement via ultrasonic method**  
 Source: Mitsubishi Hitachi Power System, Japan [6].

Faced with possibility of expanding the range of non-destructive tests that could aid the integrity evaluations results of the most critical boiler components, CBC has acquired a special hardware to measure tube wall thickness along with oxide inner scale thickness, precisely the magnetite. According to the manufacturer, the minimum thickness obtained with such a system is 0.1 mm (100 μm). The principle of measurement is shown in figure 3:

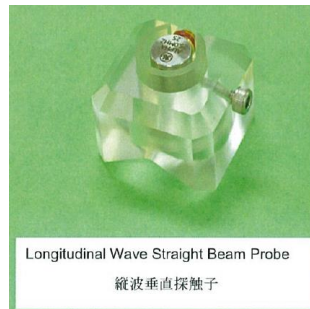
Figura 5: Longitudinal wave straight beam probe

- Ultrasonic hardware (figure 4);
- Longitudinal wave transducer (figure 5);
- Probe connecting cable
- Ultrasonic couplants

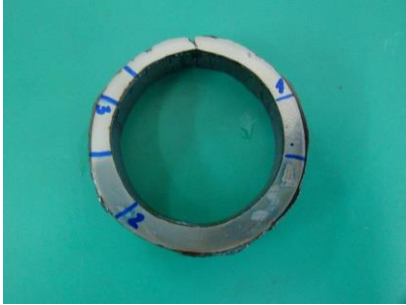
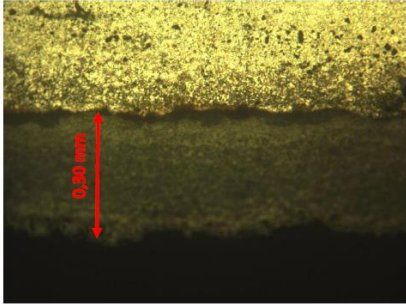
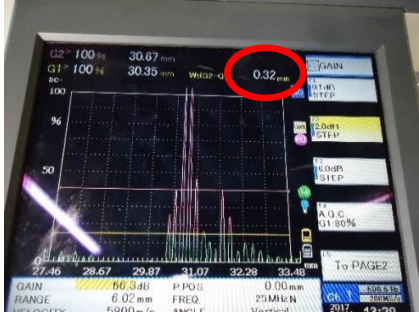
**Table 2: Sample 1 - Secondary Superheater Tube**

| | |
|--|--|
| <p>• POINT 1</p> <p>Measured thickness: 0,30mm</p> | <p>Measured thickness: 0,32mm</p> |

It is possible to observe that the measurements made by ultrasonic and optical microscopy in samples 1 and 2 show very close values and similar behaviors.

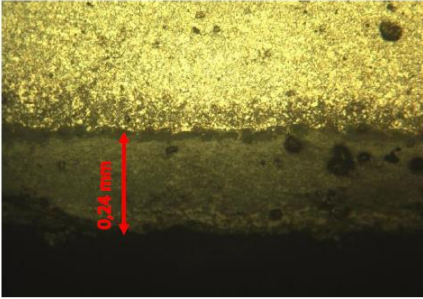
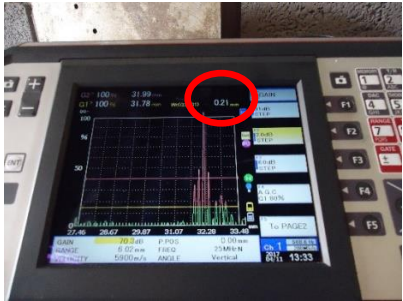
| | |
|--|--|
| <p>• POINT 2</p> <p>Measured thickness: 0,24mm</p> | <p>Measured thickness: 0,21mm</p> |

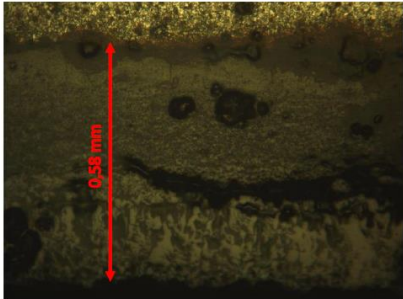
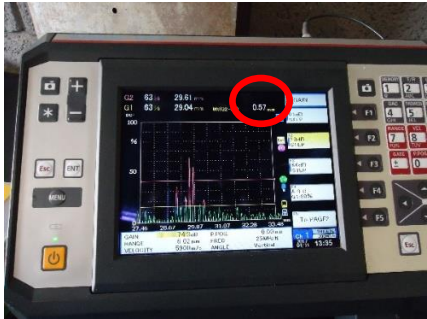
| | |
|--|--|
| <p>• POINT 3</p> <p>Measured thickness: 0,58mm</p> | <p>Measured thickness: 0,57mm</p> |

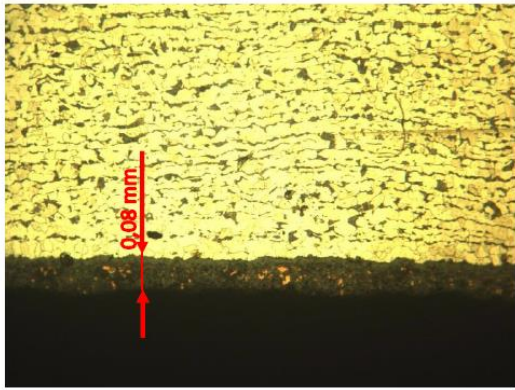
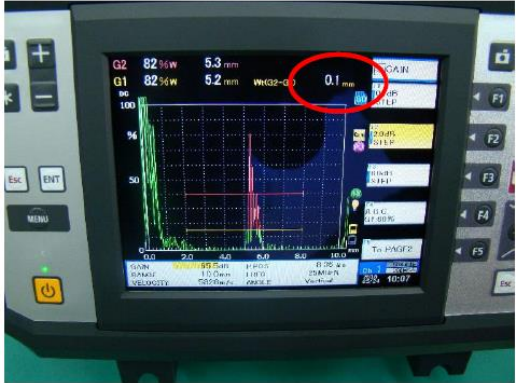
Table 3: Sample 2 - Furnace Tube

| Metallography Method | Ultrasonic Method |
|---|--|
| <p>• POINT 1</p> <p>Measured thickness: 0,08mm</p> | <p>Measured thickness: 0,1mm</p> |

For thicknesses less than 0.1 mm, it is not possible to identify a separation between the echoes referring to the steel / oxide scale and the oxide scale / air. However, in this case, the probability of metal values being within the design values is high.
